Calgon Carbon Corporation (Calgon). 9/20/05. 9:00 am. Photograph 1. Spent carbon spoil pile dredged from storm water lagoons. WK.

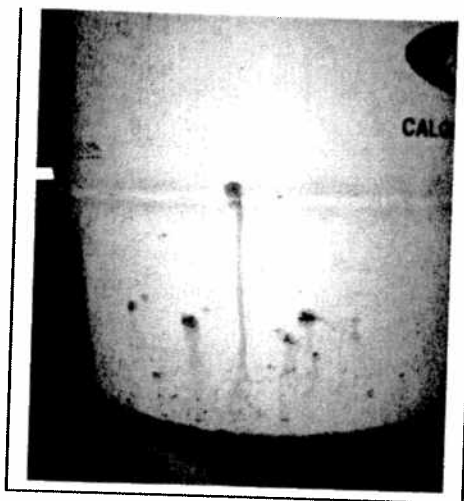
Calgon. 9/20/05. 9:00 am. Photograph 2. One 55-gallon container in permitted storage area, not in good condition. The container appears to be rusting, leaking and structurally defective. WK.

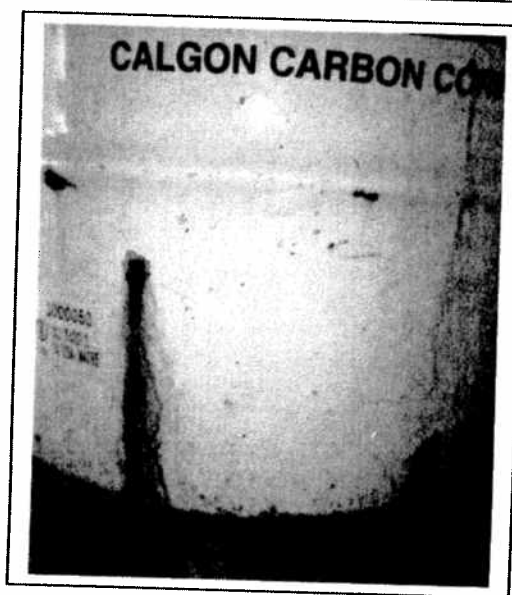
Calgon. 9/20/05. 9:00 am. Photograph 3. One 55-gallon container in permitted storage area, not in good condition. The container appears to be rusting, leaking and structurally defective. WK.

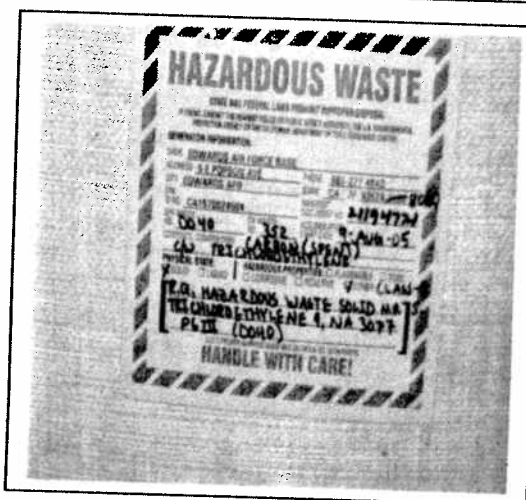
Calgon. 9/20/05. 9:00 am. Photograph 4. Label on container of hazardous waste is not marked with the date it was placed into storage. WK.

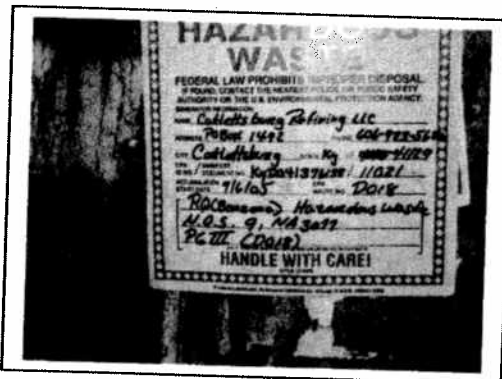
Calgon. 9/20/05. 9:00 am. Photograph 5. Label on container of hazardous waste is not marked with the date it was placed into storage. WK.

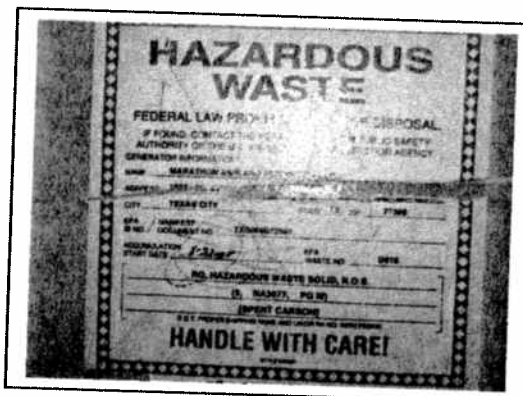
Calgon. 9/20/05. 9:00 am. Photograph 6. Label on container of hazardous waste is not marked with the date it was placed into storage. WK.

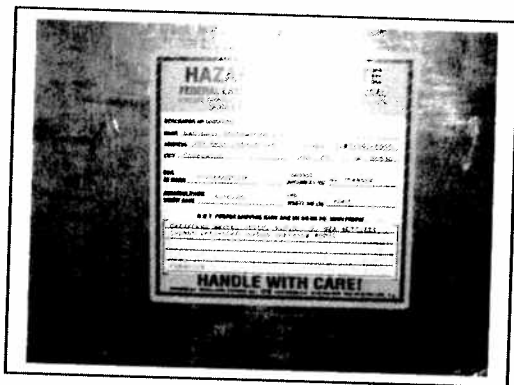
Calgon. 9/20/05. 9:00 am. Photograph 7. Label on container of hazardous waste is not marked with the date it was placed into storage. WK.

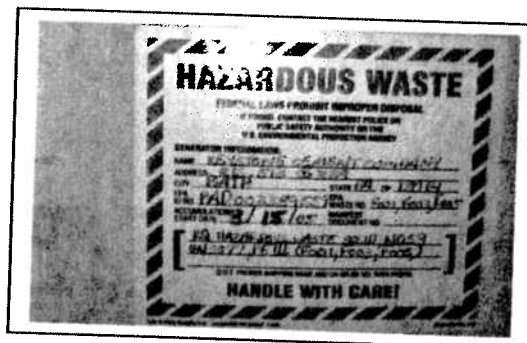
Calgon. 9/20/05. 9:00 am. Photograph 8. Label on container of hazardous waste is not marked with the date it was placed into storage. WK.

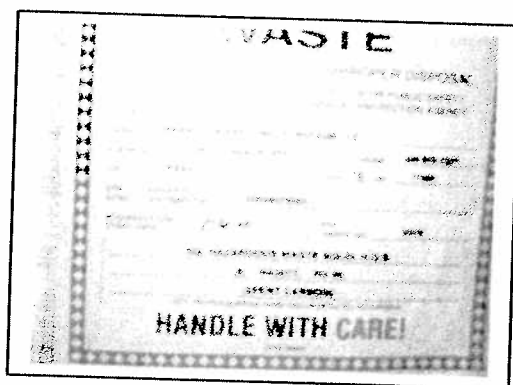
Calgon. 9/20/05. 9:00 am. Photograph 9. Label on container of hazardous waste is not marked with the date it was placed into storage. WK.

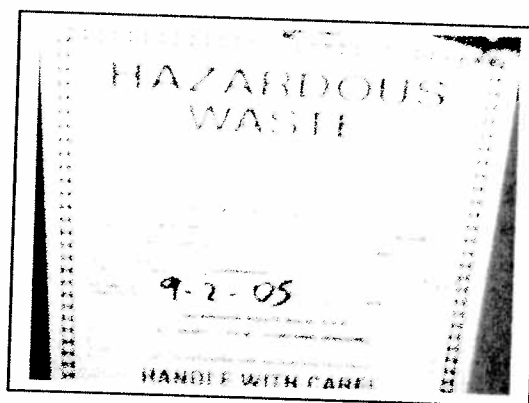
Calgon. 9/20/05. 9:00 am. Photograph 10. Label on container of hazardous waste is not marked with the date it was placed into storage. WK.

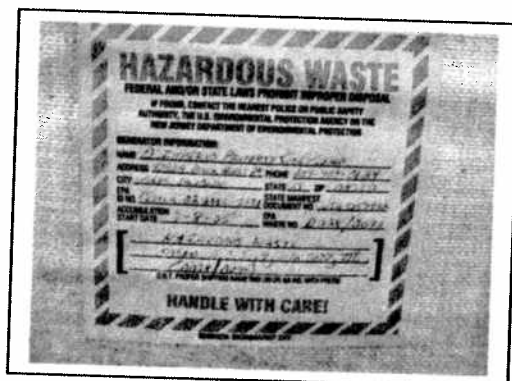
Calgon. 9/20/05. 9:00 am. Photograph 11. Label on container of hazardous waste is not marked with the date it was placed into storage. WK.

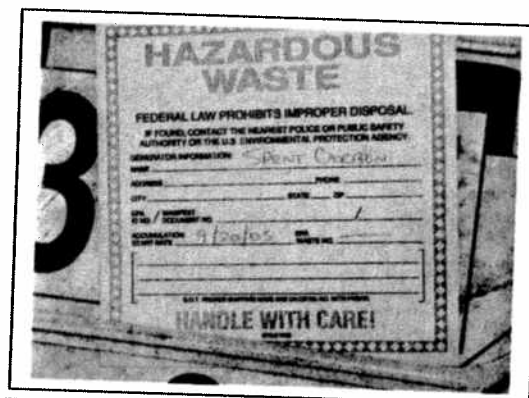
Calgon. 9/20/05. 9:00 am. Photograph 12. Label on container of hazardous waste is not marked with the date it was placed into storage. WK.

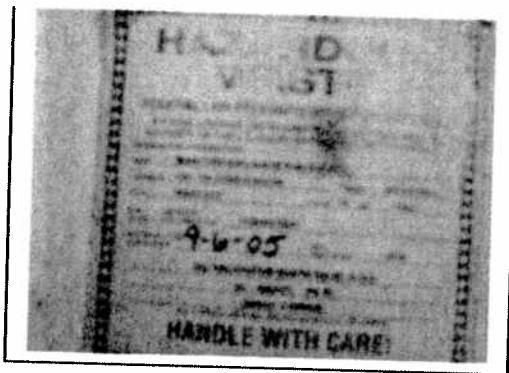
Calgon. 9/20/05. 9:00 am. Photograph 13. Label on container of hazardous waste is not marked with the date it was placed into storage. WK.

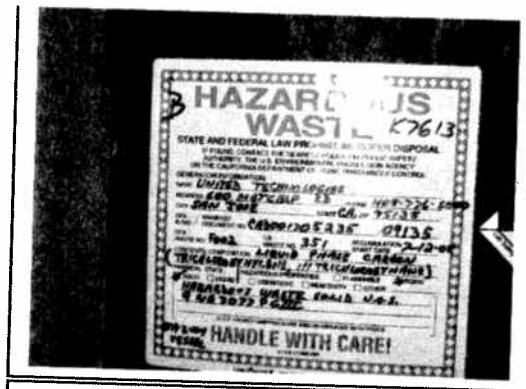
Calgon. 9/20/05. 9:00 am. Photograph 14. Label on container of hazardous waste is not marked with the date it was placed into storage. WK.

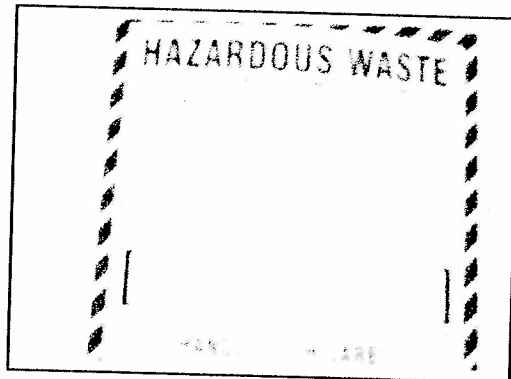
Calgon. 9/20/05. 9:00 am. Photograph 15. Label on container of hazardous waste is not marked with the date it was placed into storage. WK.

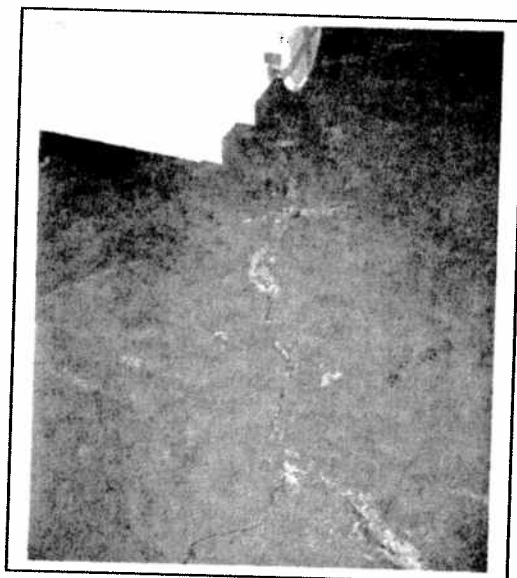
Calgon. 9/20/05. 9:00 am. Photograph 17. Permitted container storage area. The concrete floor is not free of cracks or gaps and is not sufficiently impervious to a release of hazardous

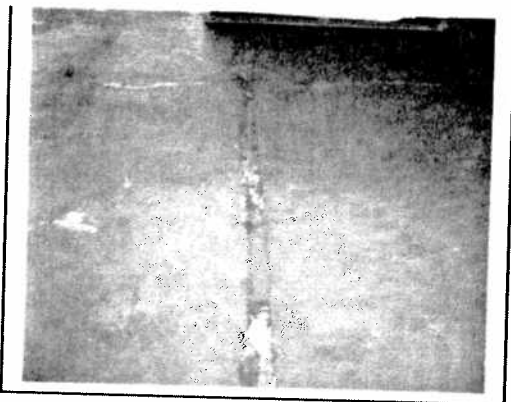
Calgon. 9/20/05. 9:00 am. Photograph 19. Permitted container storage area. The concrete floor is not free of cracks or gaps and is not sufficiently impervious to a release of hazardous waste. WK.

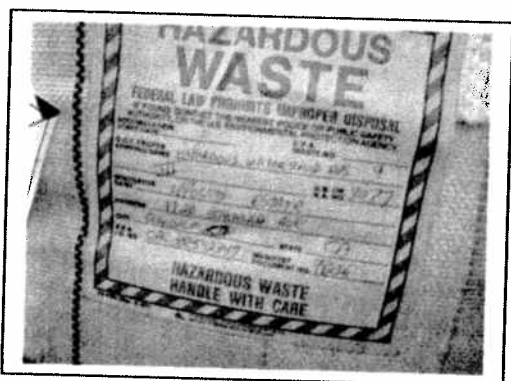
Calgon. 9/20/05. 9:00 am. Photograph 21. Outdoor storage area adjacent to Thaw Building. Label on container of hazardous waste is not marked with the date it was placed into storage. WK.

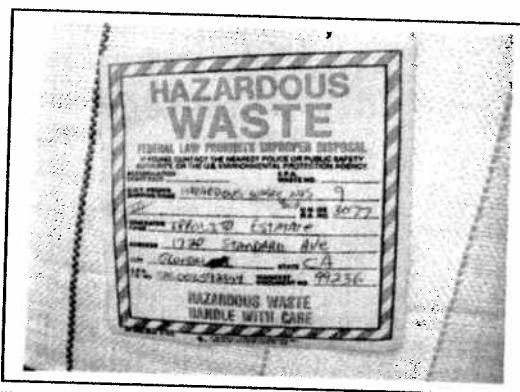
Calgon. 9/20/05. 9:00 am. Photograph 22. Outdoor storage area adjacent to Thaw Building. Label on container of hazardous waste is not marked with the date it was placed into storage. WK.

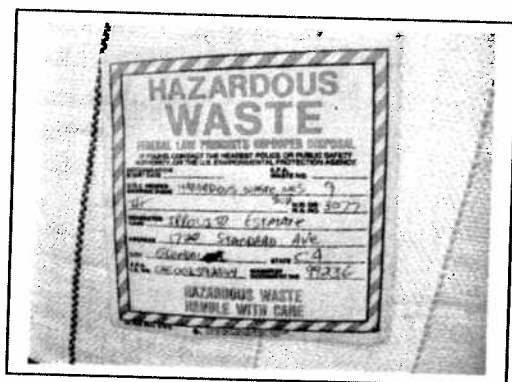
Calgon. 9/20/05. 9:00 am. Photograph 23. Outdoor storage area adjacent to Thaw Building. Label on container of hazardous waste is not marked with the date it was placed into storage. WK.

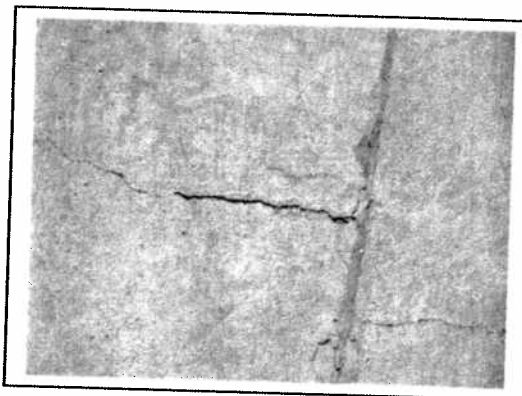
Calgon. 9/20/05. 9:00 am. Photograph 24. Outdoor concrete surface in front of Thaw Building. The surface is not free of cracks or gaps and is not sufficiently impervious to a release of hazardous waste. WK.

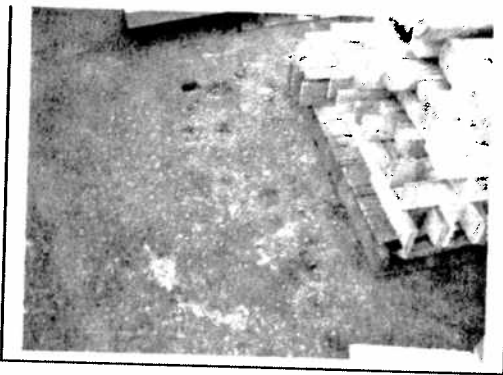
Calgon. 9/20/05. 9:00 am. Photograph 25. Outdoor concrete surface in front of Thaw Building. Release of hazardous waste slag from container to ground. Observed cracks or gaps and surface is not sufficiently impervious to a release of hazardous waste. WK.

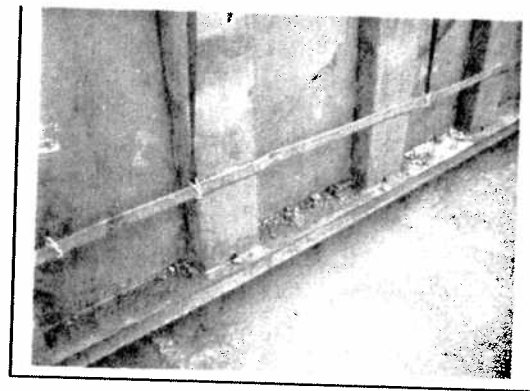
Calgon. 9/20/05. 9:00 am. Photograph 26. Outdoor concrete surface in front of Thaw Building. Release of hazardous waste slag from container to ground. The surface is not free of cracks or gaps and is not sufficiently impervious to a release of hazardous waste. WK.

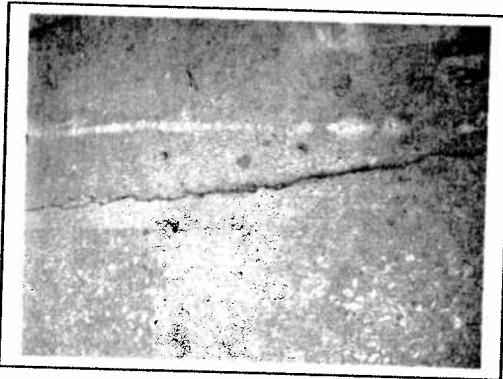
Calgon. 9/20/05. 9:00 am. Photograph 27. Outdoor concrete surface in front of Thaw Building. Release of hazardous waste from container to ground. The surface is not free of cracks or gaps and is not sufficiently impervious to a release of hazardous waste. WK.

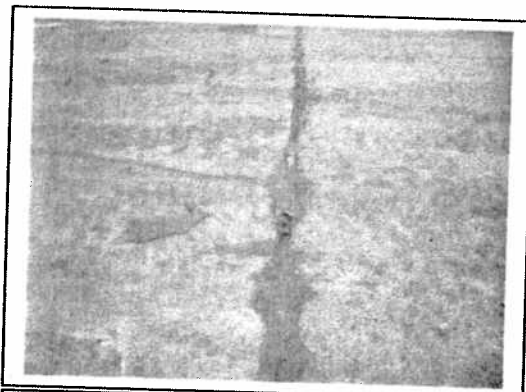
Calgon. 9/20/05. 9:00 am. Photograph 28. Outdoor concrete surface in front of Thaw Building. The surface is not free of cracks or gaps and is not sufficiently impervious to a release of hazardous waste. WK.

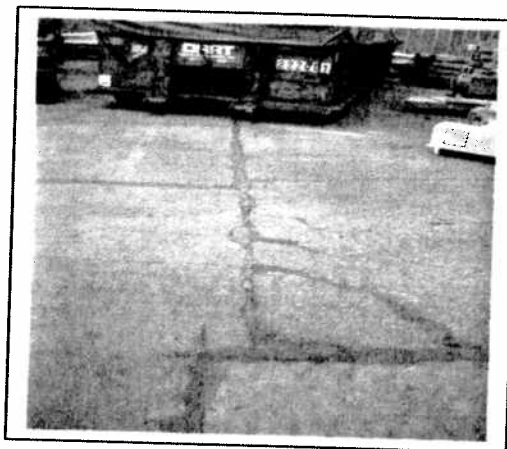
Calgon. 9/20/05. 9:00 am. Photograph 29. Outdoor concrete surface in front of Thaw Building. The surface is not free of cracks or gaps and is not sufficiently impervious to a release of hazardous waste. WK.

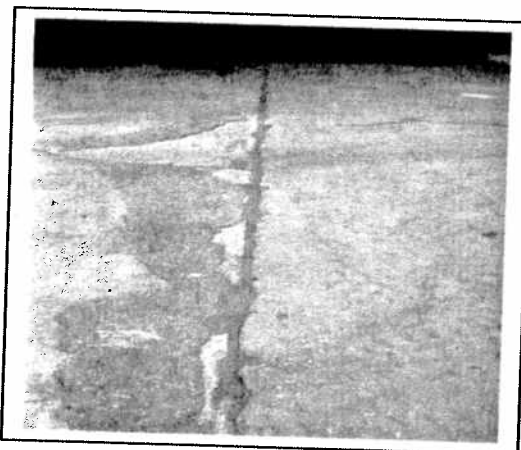
Calgon. 9/20/05. 9:00 am. Photograph 30. Outdoor concrete surface in front of Thaw Building. The surface is not free of cracks or gaps and is not sufficiently impervious to a release of hazardous waste. WK.

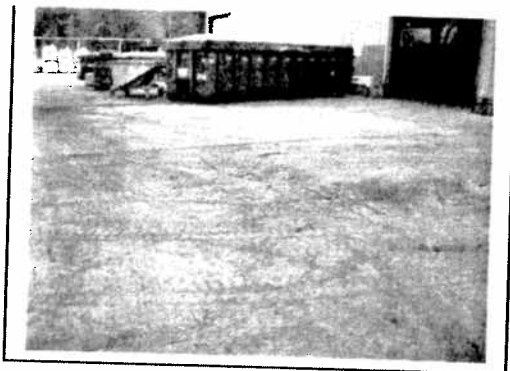
Calgon. 9/20/05. 9:00 am. Photograph 31. Outdoor concrete surface in front of Thaw Building. Note tire tracks on pavement and the spread of spent carbon on surface not free of cracks or gaps. WK.

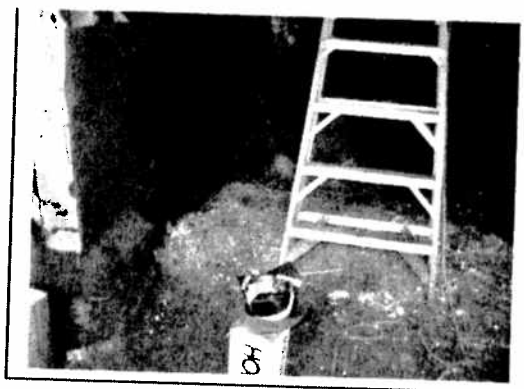
Calgon. 9/20/05. 9:00 am. Photograph 32. SDA Area. Contractor is working on SDA unit. Hazardous waste SDA fines in containment area surrounding ladder resulting in a release of hazardous waste. WK.

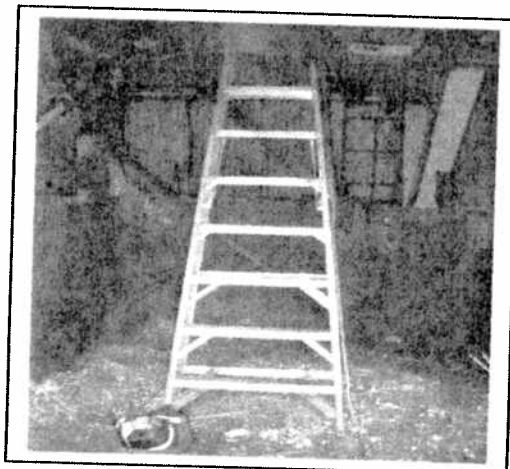
Calgon. 9/20/05. 9:00 am. Photograph 33. SDA Area. Contractor is working on SDA unit. Hazardous waste SDA fines in containment area surrounding ladder resulting in a release of hazardous waste. WK.

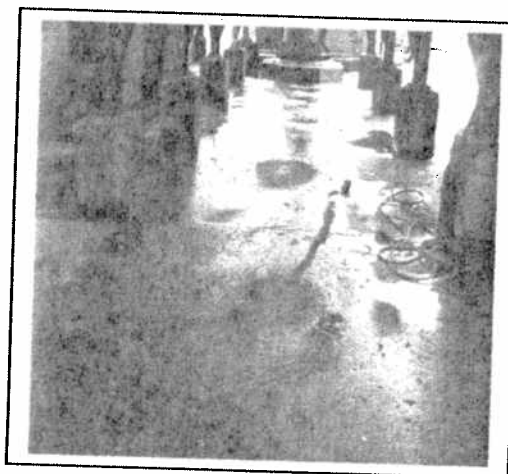
Calgon. 9/20/05. 9:00 am. Photograph 34. Bag house accumulation area. Release of bag house to floor resulting in a release of hazardous waste. WK.

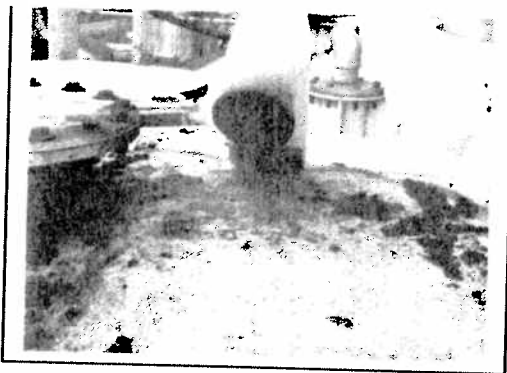
Calgon Carbon Corporation (Calgon). 9/21/05. 8:00 am. Photograph 35. Part B permitted Hazardous Waste Storage Tank Area B. Release of spent carbon from vent to top of tank D-701. WK.

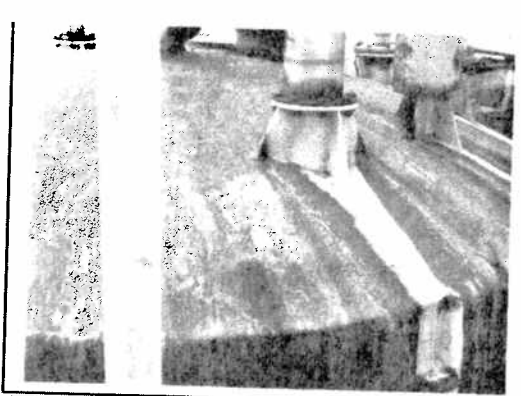
Calgon. 9/21/05. 8:00 am. Photograph 36. Part B permitted Hazardous Waste Storage Tank Area B. Release of spent carbon from vent to top of tank. WK.

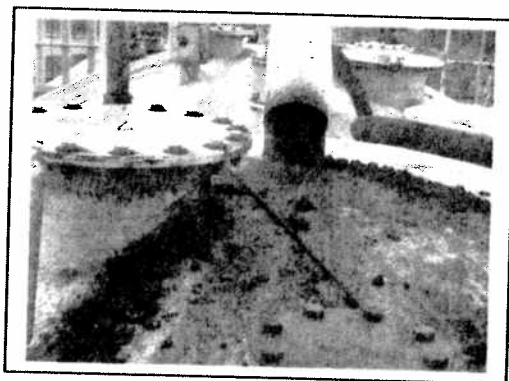
Calgon. 9/21/05. 8:00 am. Photograph 37. Part B permitted Hazardous Waste Storage Tank Area B. Release of spent carbon from vent to top of tank D-702. WK.

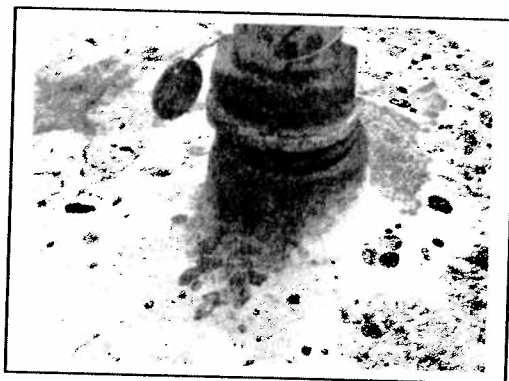
Calgon. 9/21/05. 8:00 am. Photograph 39. Part B permitted Hazardous Waste Storage Tank Area B. Disconnect tank level indicator (Bin Cable) from top of tank 70. Release of spent carbon from vent to top of tank D-704. WK.

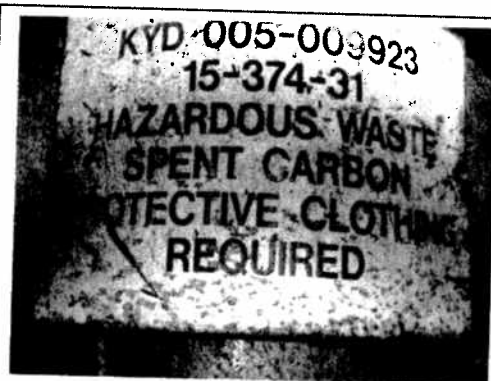
Calgon. 9/21/05. 8:00 am. Photograph 40. Part B permitted Hazardous Waste Storage Tank Area B. Hazardous waste label attached to storage tank in area B. Past release of hazardous waste observed on label. WK.

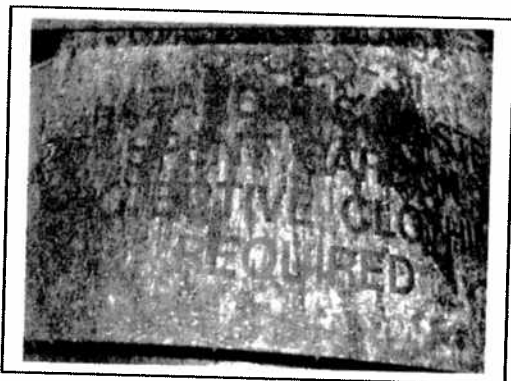
Calgon. 9/21/05. 8:00 am. Photograph 41. Part B permitted Hazardous Waste Storage Tank Area B. Hazardous waste label attached to storage tank in area B. Past release of hazardous waste observed on label. The label can not be clearly read as a result of the release. WK.

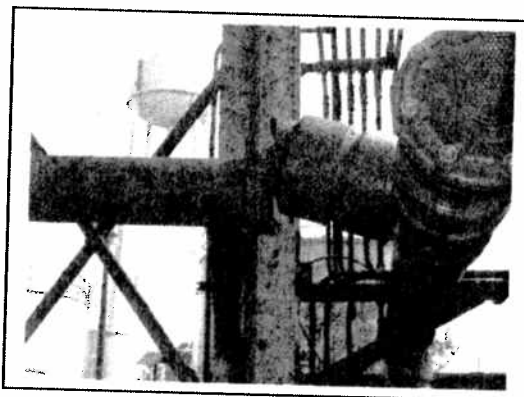
Calgon. 9/21/05. 8:00 am. Photograph 42. Part B permitted Hazardous Waste Storage Tank Area B. Main vent line is broken. The vent line is connected to a carbon adsorption unit, which treats RCRA tank air emissions. WK.

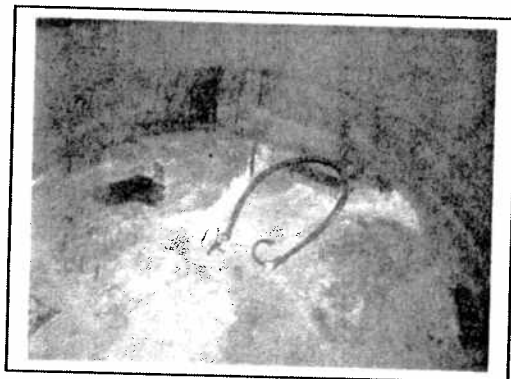
Calgon. 9/21/05. 8:00 am. Photograph 43. Pro Shop. Solid waste accumulating in tank located inside building. Note debris in tank. WK.

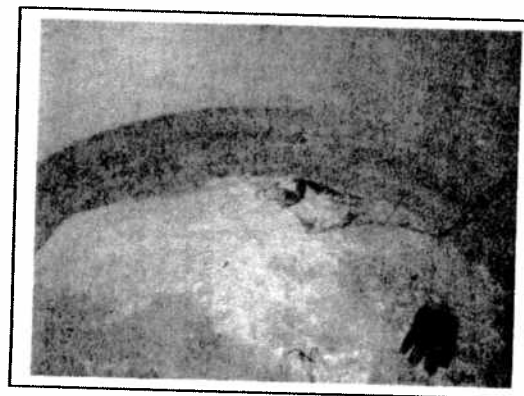
Calgon. 9/21/05. 8:00 am. Photograph 44. Pro Shop. Solid waste accumulating in tank located inside building. Note debris in tank. WK.

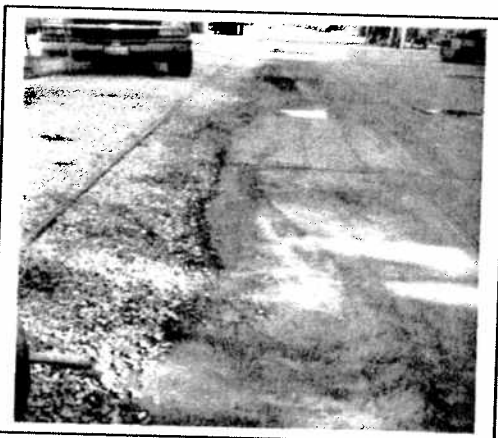
Calgon. 9/21/05. 8:00 am. Photograph 45. Area adjacent to CRU building. Spent carbon release to paved and unpaved ground. WK.

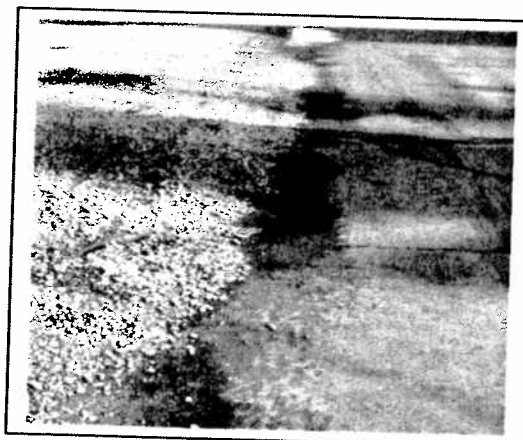
Calgon. 9/21/05. 8:00 am. Photograph 46. Area adjacent to CRU building. Spent carbon release to paved and unpaved ground. WK.

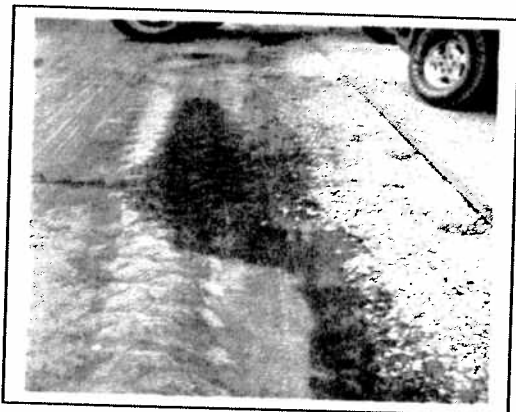
Calgon. 9/21/05. 8:00 am. Photograph 47. Area adjacent to CRU building. Spent carbon release to paved and unpaved ground. Note tire tracks. WK.

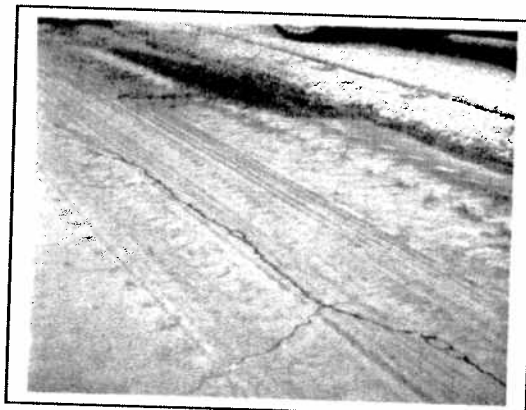
Calgon. 9/21/05. 8:00 am. Photograph 48. Area adjacent to CRU building. Spent carbon release to paved and unpaved ground. WK.
